Region 9 Enforcement Division 75 Hawthorne Street San Francisco, CA 94105

Inspection Date(s):	August 22, 2019		
Time:	Entry: 7:45 am Exit: 2:30 pm		
Media:	Water		
Regulatory Program(s)	Clean Water Act NPDES		
Company Name:	Dos Cuadras Offshore Resources, LLC (DCOR)		
Facility or Site Name:	Platform Habitat		
Facility/Site Physical	Platform Gilda, Santa Barbara Channel, Pacific Ocean		
Location:	Lease OCS-P-0216		
Geographic Coordinates:	34°10'56.42"N, 119°25'6.83"W		
Mailing address:	290 Maple Court, Suite 290		
_	Ventura, CA 93003		
Facility/Site Contact:	Jay Rao		Title: Environmental Engineer
	Phone : 805-53	35-2078	Email: jrao@dcorllc.com
Facility/Site Identifier:	NPDES Permits CAG280000 and CAF001152		
NAICS:	211111 - Crude petroleum and natural gas extraction		
SIC:	1311		
Facility/Site Personnel Participating in Inspection:			
Name	Affiliation	Title	Email
Jay Rao	DCOR	Environmental	jrao@dcorllc.com
		Engineer	
Sean Smith	DCOR	Lead Operator	ssmith@dcorllc.com
EPA Inspector(s):

SECTION I – INTRODUCTION

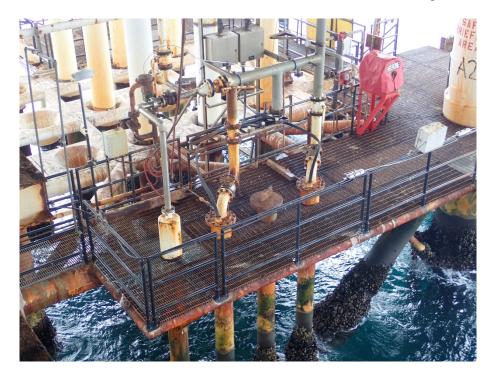
Solution recovered from the formation by both Platform Gilda and Platform Gina goes through a separator where "sour" natural gas is captured. Sour natural gas goes through an "Amine" plant to strip out hydrogen sulfide. Natural gas is then sent through a pipeline (Photograph 1) to shore for sale. Gross production fluids are combined with those from Platform Gina and sent via a different pipeline to Mandalay Onshore Treatment Facility, where oil is separated out for sale and produced water is pumped back to Gilda for injection and discharge (Discharge 002).

Photograph 1: Pipeline gallery.

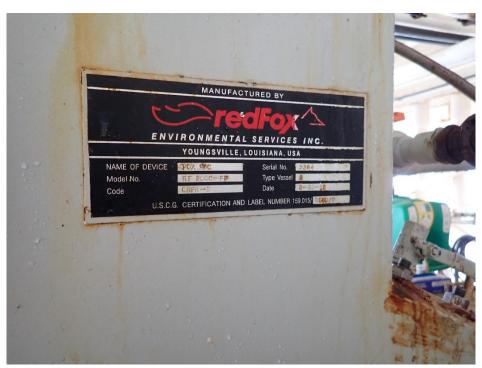
Sanitary Wastewater (Discharge 005) is treated onsite at the Facility with a redFox FoxPac environmental marine sanitation device (MSD) Model No. RF 2000-FP with serial No. 5384, which is United States Coast Guard (USCG) approved (Photograph 2). The treated water is discharged (Discharge 005) to the Pacific Ocean via a pipe (Photograph 2). The onsite Facility representatives stated that the daily discharge water flow rate is estimated based on the number of people on the platform and the time spent per person. The MSD unit is sized for a maximum of 2,000 gallons per day (gpd).

Photograph 2: Marine Sanitation Device.

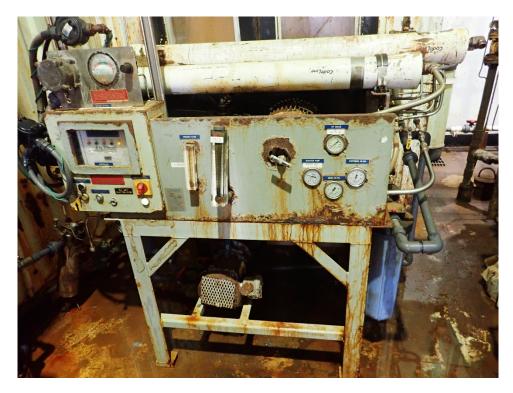
Desalination (i.e., reverse osmosis) unit wastewater (Discharge 007) is generated during the process of creating freshwater from saltwater. The desalination unit (Photograph 3) discharges directly to the Pacific Ocean via a pipe.

Photograph 3:RO unit.

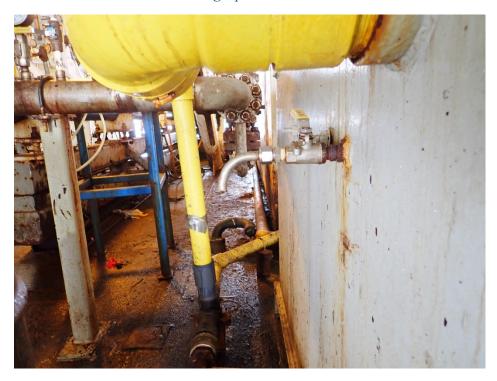
Produced water is sampled every 12 hours from the port shown in Photograph 4 and analyzed onsite for hydrogen sulfide and Oil & Grease concentrations. Hydrogen sulfide tests are performed with paper test strips. Oil & Grease samples are analyzed using a photospectrometer (Photograph 5). Produced water flows are calculated from pump capacity and run times.

Photograph 4:Sample port for produced water discharge.

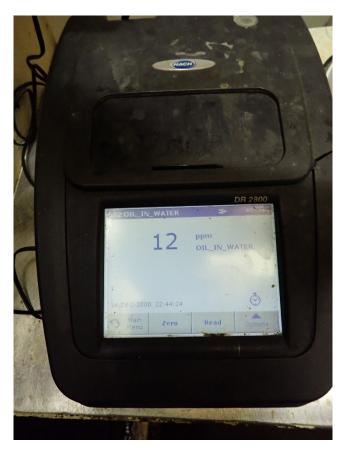
Photograph 5 : Photospectrometer for measuring Oil & Grease.

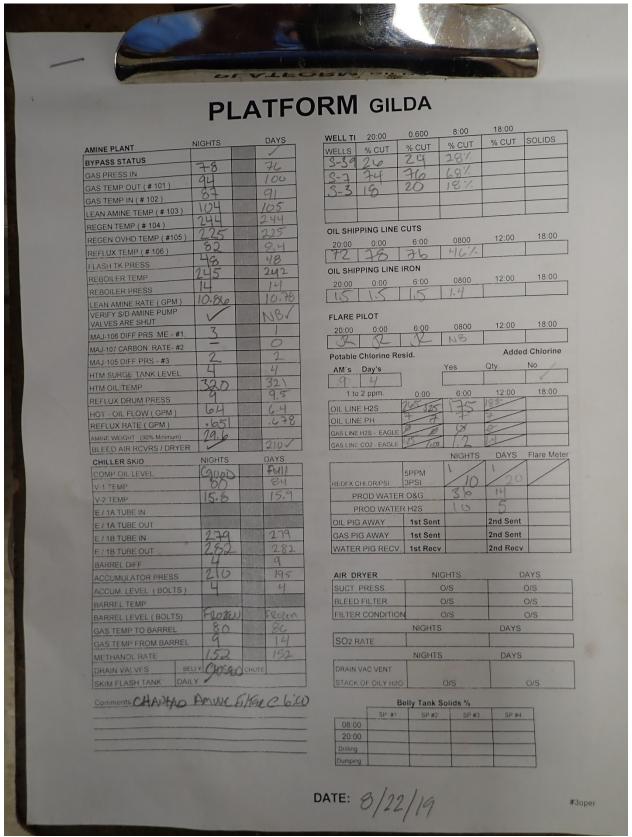
- The NPDES permit, daily reports, and DMRs were all well organized and readily available on an electronic share drive accessible on the Platform. Daily log sheets were clear, well kept, and easy to understand (Photograph 6).
- The platform had significant rust and corrosion.

Photograph 6: Daily log sheet.
